# Corrosion and scaling at Cerro Prieto geothermal field

**Purpose** – The aim of this work is to study the corrosion and scaling factors, mechanisms and processes affecting the materials, equipment and installations of the Cerro Prieto geothermal field (GTF).

**Keywords** Geothermal power, Pollution, Corrosion

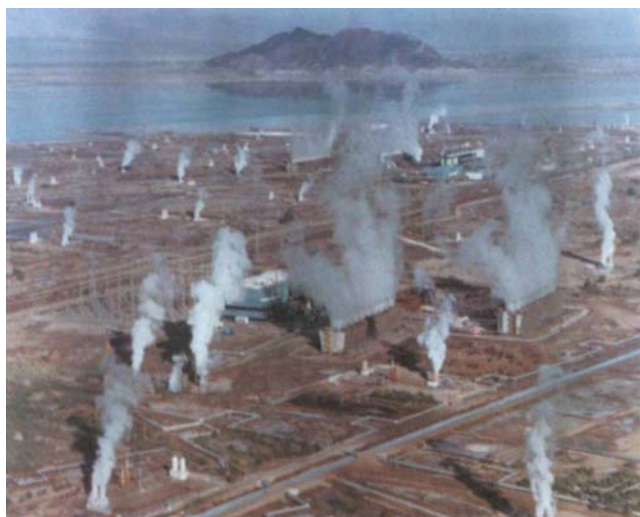
**Figure 1** Geothermal field at Cerro Prieto

The information provided in this paper is focused on experiences with scaling and corrosion processes occurring in the GTF of Mexico, mainly at Cerro Prieto (Figure 1), where the climate conditions and the physicochemical characteristics of the GT fluid (brines, water and steam) promote the occurrence of these phenomena.

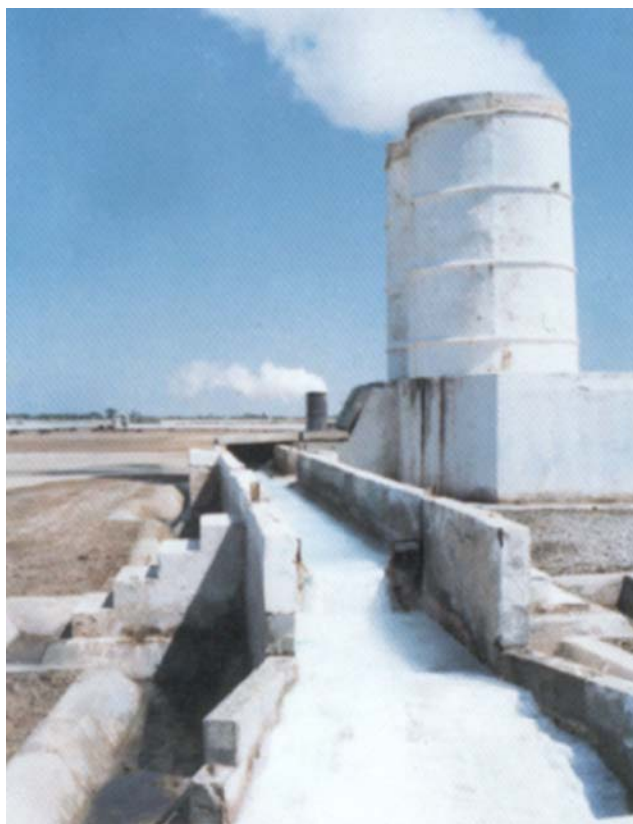
**Figure 2** Deterioration by corrosion of brine conducting canals and silencer house built with reinforced concrete

The susceptible concrete structures function as support bases of buildings, steam silencers, ditches and steam pipelines. All the concrete structures at Cerro Prieto are in various stages of degradation due to the GT aggressive environment. Figure 2 shows the deterioration by corrosion of brine conducting canals and the RC of the silencer house building.

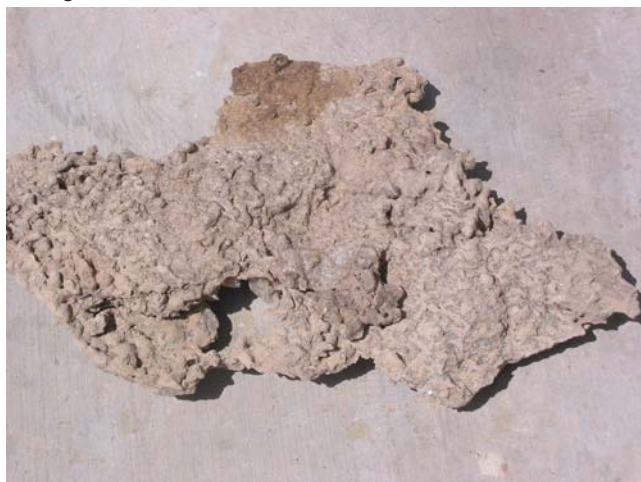
**Figure 5** Silica scaling sample removed from a steam pipeline at Cerro Prieto geothermal field

As  $\text{CO}_2$  is removed, more  $\text{CaCO}_3$  incrusts the casing surface. These scales plug the casings and the pipelines and interfere with GT fluid flow. Silicate scales are very tenacious, dense and difficult to remove from the hot surfaces. A particular black incrustation, constituted by  $\text{SiO}_2$  contaminated with black  $\text{FeS}$ , forms a hard adherent dense layer, which frequently obstructs the casing in Cerro Prieto GTW (Ocampo *et al.*, 2005). Sometimes the  $\text{SiO}_2$  becomes light grey, reflecting a gradual decrease in the abundance of black  $\text{FeS}$ . In other cases, scales at the well head consist of black, sooty sulphides of Fe, Pb, Zn and Cu. They also appear as concentrated layers at the bottom of flow lines. An amorphous iron silicate becomes abundant too.
