# Experimental Findings for the Sealing and Corrosion Inhibition Properties of Vappro VBCI Corro-Tape Using ASTM B117 Salt-Spray Chamber Test

<sup>1</sup>Magna International Pte Ltd  
Singapore

## Abstract

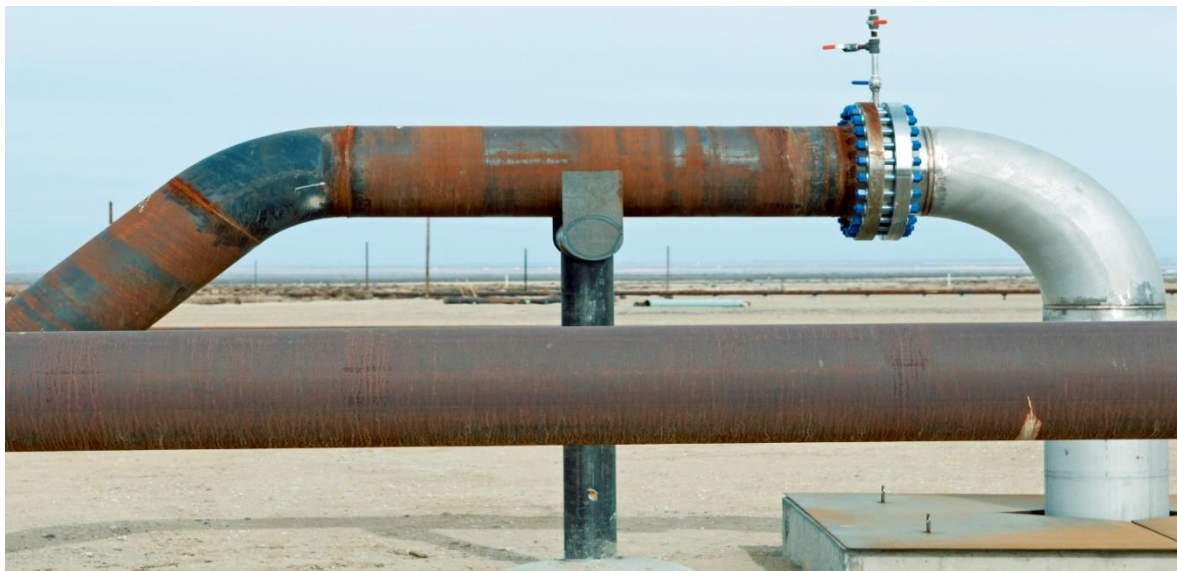
Picture 1-Uniform Corrosion of Pipelines

Uniform Corrosion [5,6,7,8] ensues at uniform rate over most of the surfaces throughout the pipe lengths. It is commonly found in pipelines that are not protected by surface coatings or inhibitors. A surface of rust is formed on the surface

of the pipelines when exposed to corrosive environment such as marine environment (see picture1).

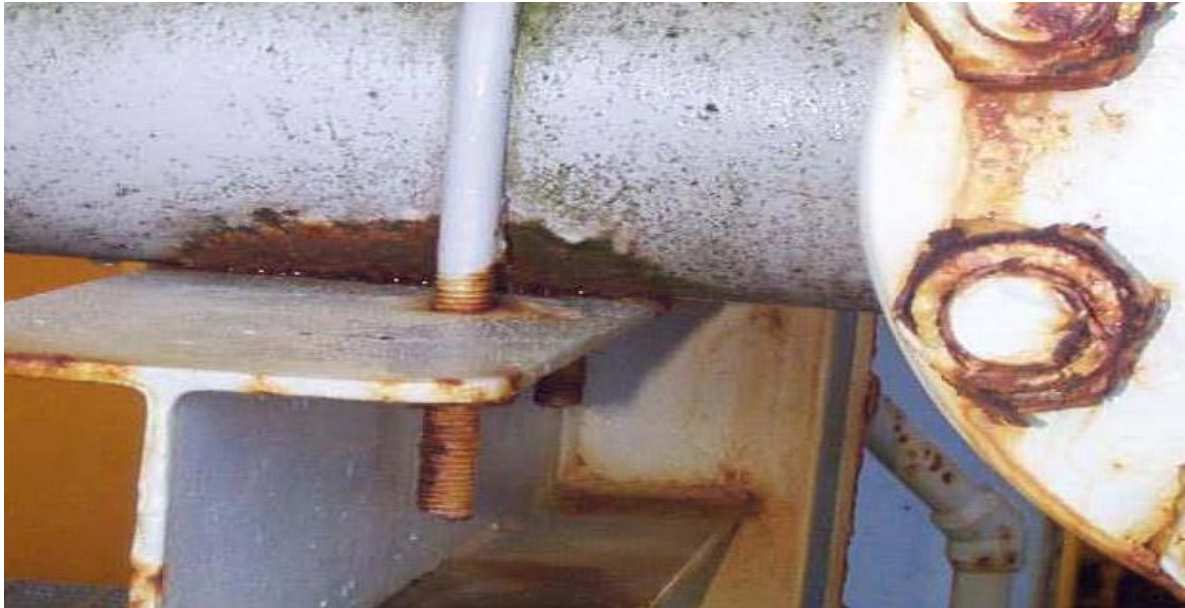
Picture 2-Crevice Corrosion of Pipeline

Crevice Corrosion [9,10,11] is a type of localized corrosion usually associated with stagnation of water in a micro-environmental level. Such stagnant micro-environments tend to occur in crevices in shielded areas such as gaskets, joints of pipelines, washers, insulation materials and surface deposits (see picture 2).

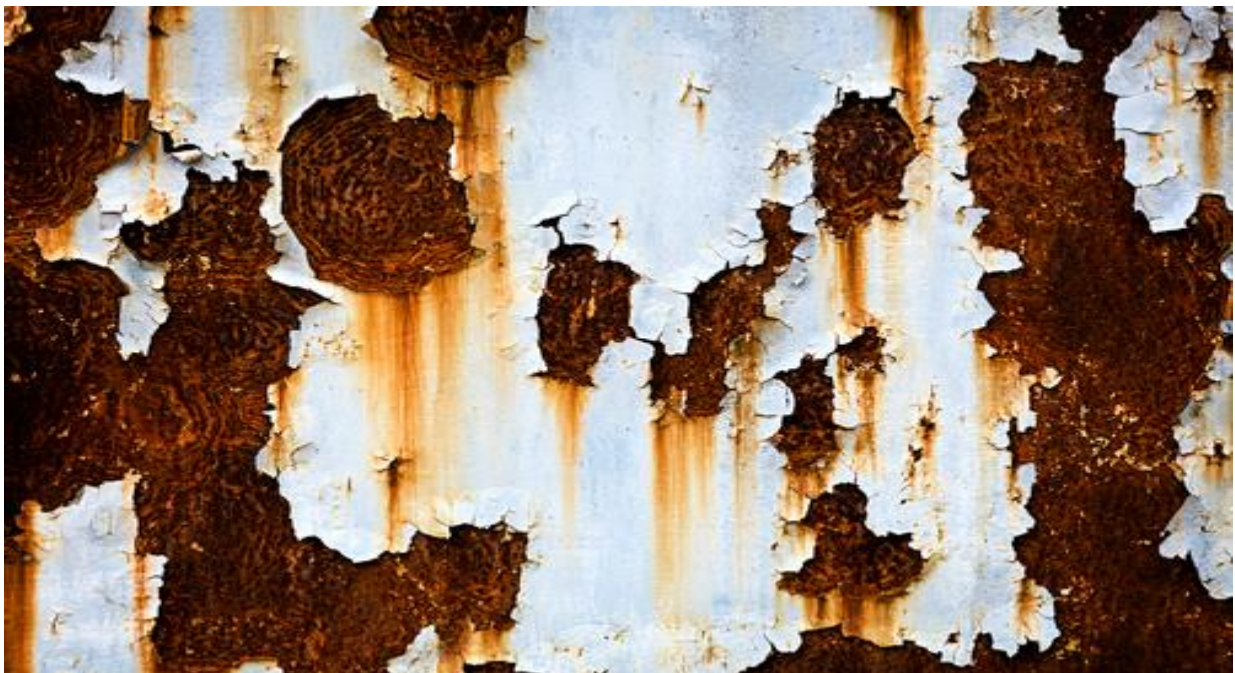
Picture 3-Filiform Corrosion on the surface of a pipeline

Whereas extreme localization corrosion such as filiform corrosion [12,13,14] is commonly experienced due to hostile marine local environment for pipelines above ground. Filiform corrosion or filamentary corrosion occurs under the protective paints or coatings due to poor surface preparation before the paint was applied on the surface. It is also referred to as under-film corrosion (see picture 3).

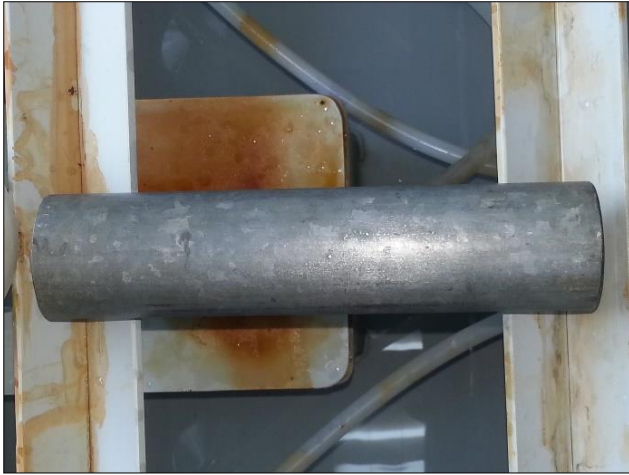
Picture (4) Galvanized pipe.

A galvanized pipe without any anti-corrosion tape (Please refer to picture 4) and a high carbon steel pipe wrapped with Vapro VBCI Corro-Tape (Please refer to picture 5).

Galvanized pipe without wrapping with Vapro VBCI Corro-Tape is used as a control blank trial. By means of a blank trial – that is, a trial structure without VCI auxiliary packing material – it is determined whether the conditions of the trial are sufficient to cause corrosion to appear on the unprotected test sample.

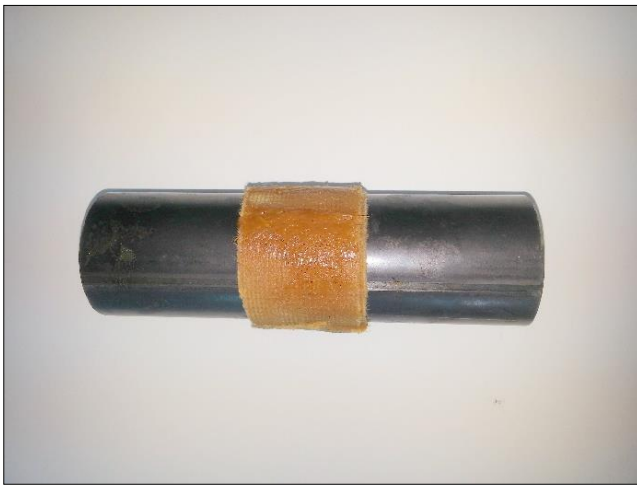
Picture (5) High Carbon Steel Pipe wrapped with Vapro VBCI Corro-Tape.

Both pipes were degreased and cleaned with Isopropyl Alcohol and the center portion of the high carbon pipe was wrapped with Vapro VBCI Corro-Tape. Then both were placed in the salt spray chamber.

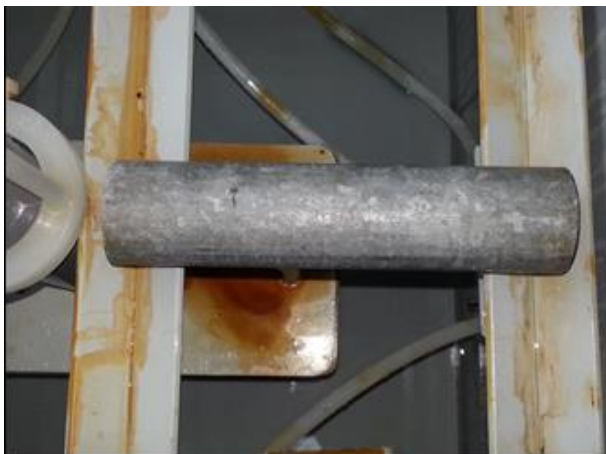
Picture (6) after 48 hours in the salt spray chamber.

Some white rust of was found on galvanized pipe. (Please refer to picture 6)  
However, for the high carbon steel pipe, corrosion was observed on both sides of the pipe that were not protected by with Vapro VBCI Corro-Tape. (Please refer to picture 7)

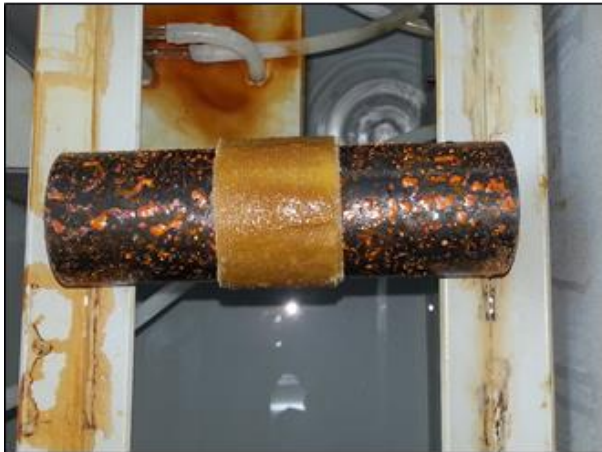
Picture (7) after 48 hours in the salt spray chamber.

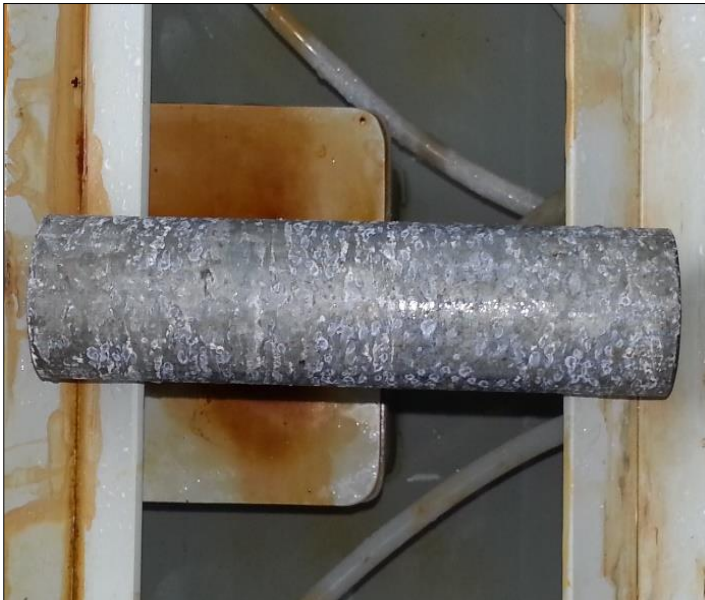
Picture (8) after 100 hours in the salt spray chamber.

More white rust was found on galvanized pipe. (Please refer to picture 8)  
For the high carbon steel pipe, the exacerbation of corrosion was observed on both the unprotected sides. (Please refer to picture 9)

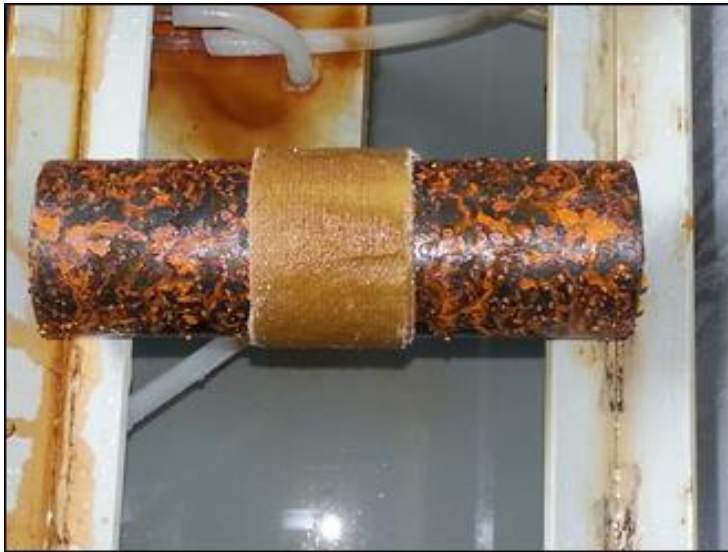
Picture (9) after 100 hours in the salt spray chamber

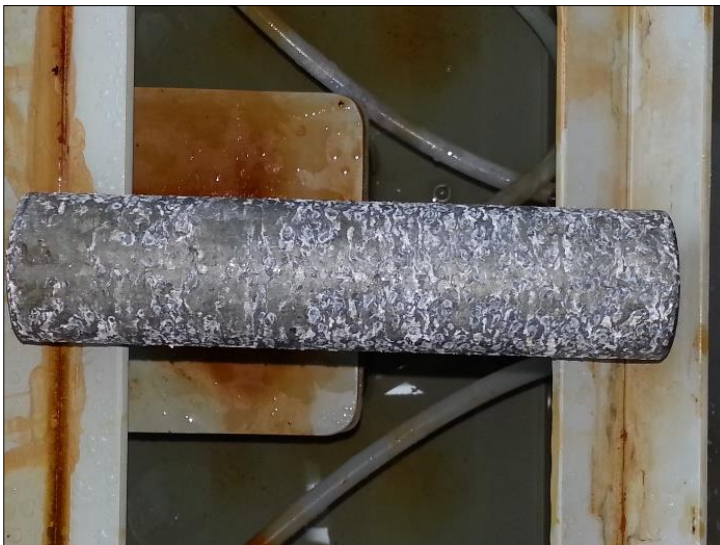
Picture (10) after 500 hours in the salt spray chamber.

Extensive white rusts were observed on the galvanized pipe. (Please refer to picture 10)  
For the high carbon steel pipe wrapped with Vapro VCI Corro-Tape, 80% of the unprotected surface areas were corroded. (Please refer to picture 11)

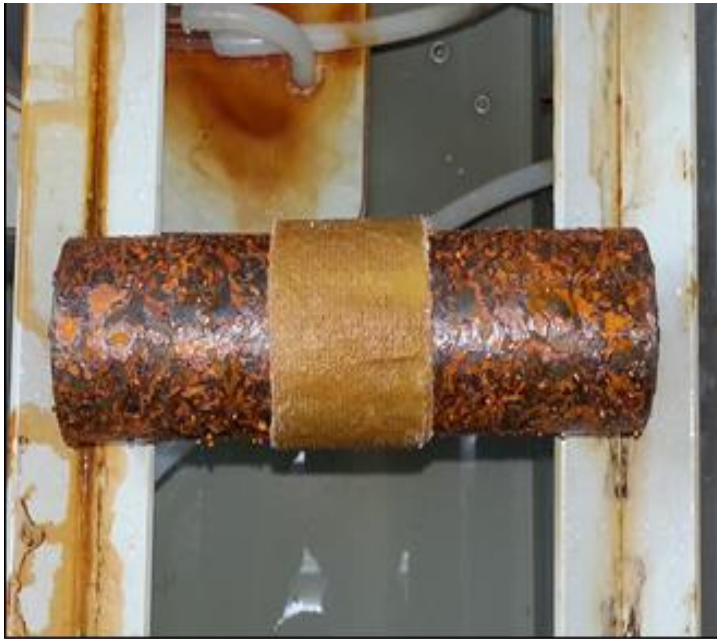
Picture (11`) after 500 hours in the salt spray chamber.

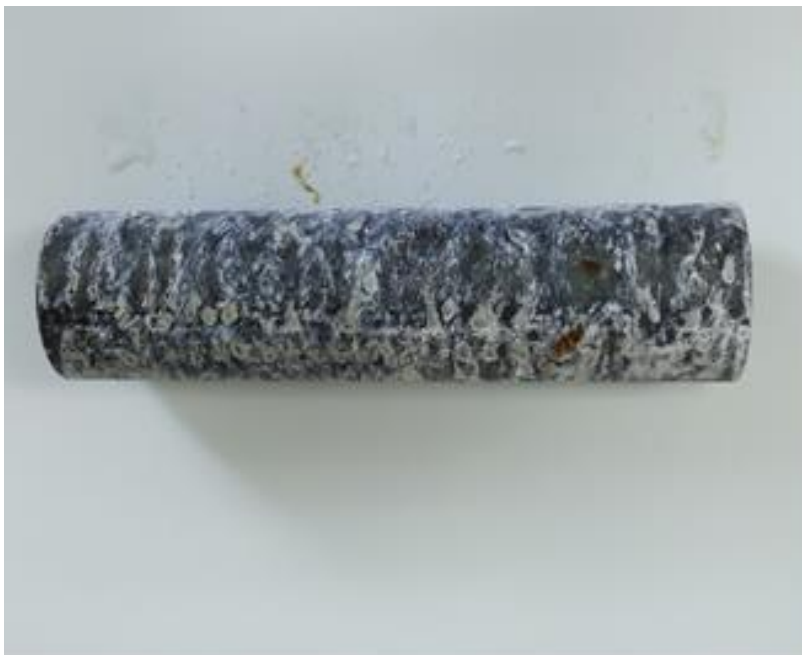
Picture (12) after 1000 hours in the salt spray chamber.

Extensive severe white rusts were observed at the galvanized pipe. (Please refer to pictures 12) For pipe wrapped with Vapro VBCI Corro-Tape, 95% of the unprotected surface area were corroded. (Please refer to picture 13)

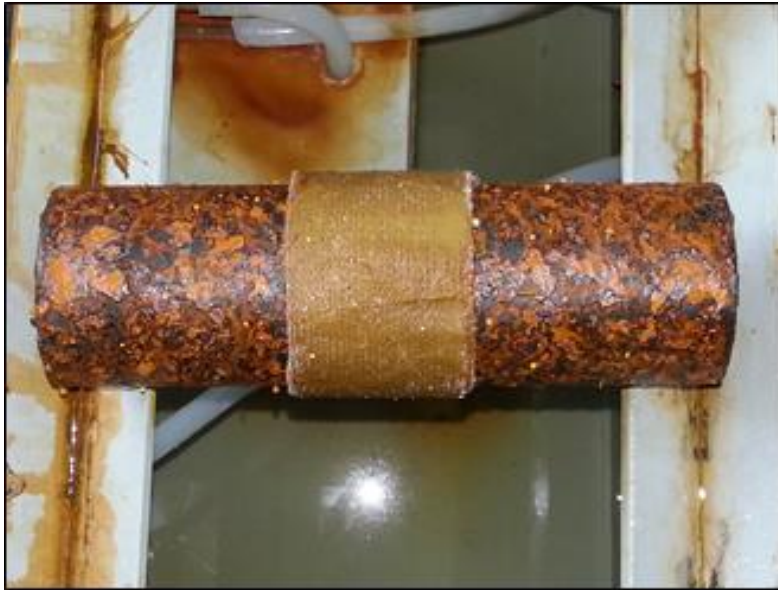
Picture (13) after 1000 hours in the salt spray chamber

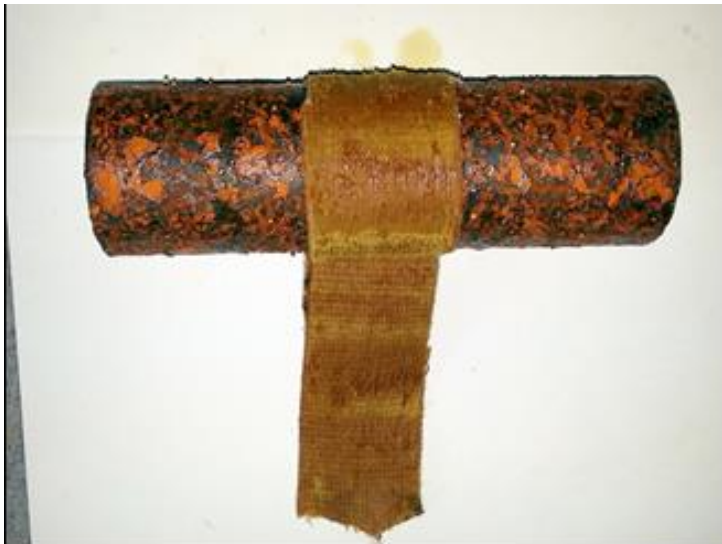
Picture (14) Vapro VCI Corro-Tape was unwrapped for observation

Vapro VBCI Corro-Tape was unwrapped from the center portion of the high carbon steel pipe and observed the protected surface area. (Pls refer to picture 14)

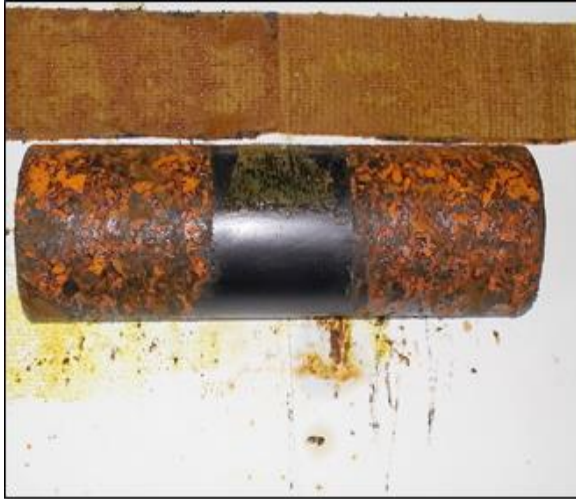
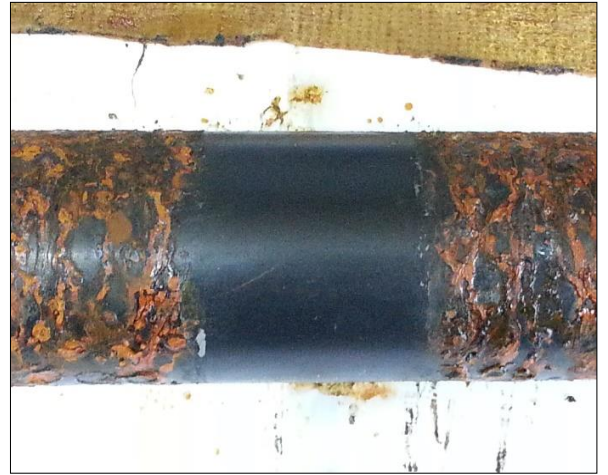
No sign of corrosion was observed on the protected surface area wrapped with Vapro VCI Corro-Tape.

No sign of corrosion was observed on protected surface area wrapped with Vapro VBCI Corro-Tape. (Please refer to picture 15 and 16)
